# Correlation of Accelerated Weathering, Natural Weathering, and Field Lenses for Protective Coatings Utilized in Forward Lighting

Sona Slocum, Steven Mordhorst

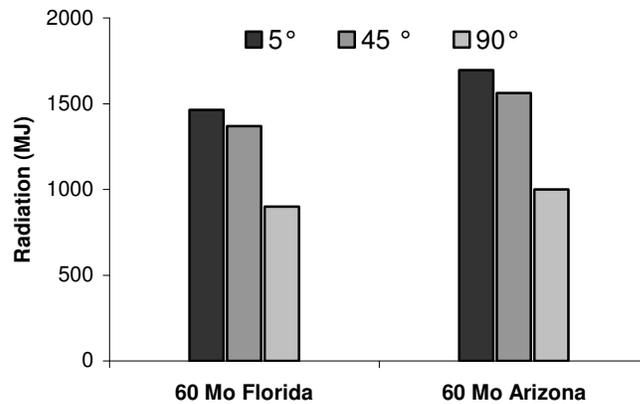
Figure 1. Relative radiation difference based on part angle to horizontal.<sup>3</sup>

The near horizontal design of headlamps has further increased the need for weathering protection. It is well established that a horizontal surface undergoes faster degradation due to higher direct UV incidence relative to a vertical surface, which receives less direct and more diffuse/reflected UV incidence. Figure 1 shows a comparison of UV irradiance levels on parts at 5°, 45°, and 90° to the horizontal in Florida. A part at 5° to the horizontal receives over 1.5 times the UV radiation as a part at 90° to the horizontal.<sup>3</sup>

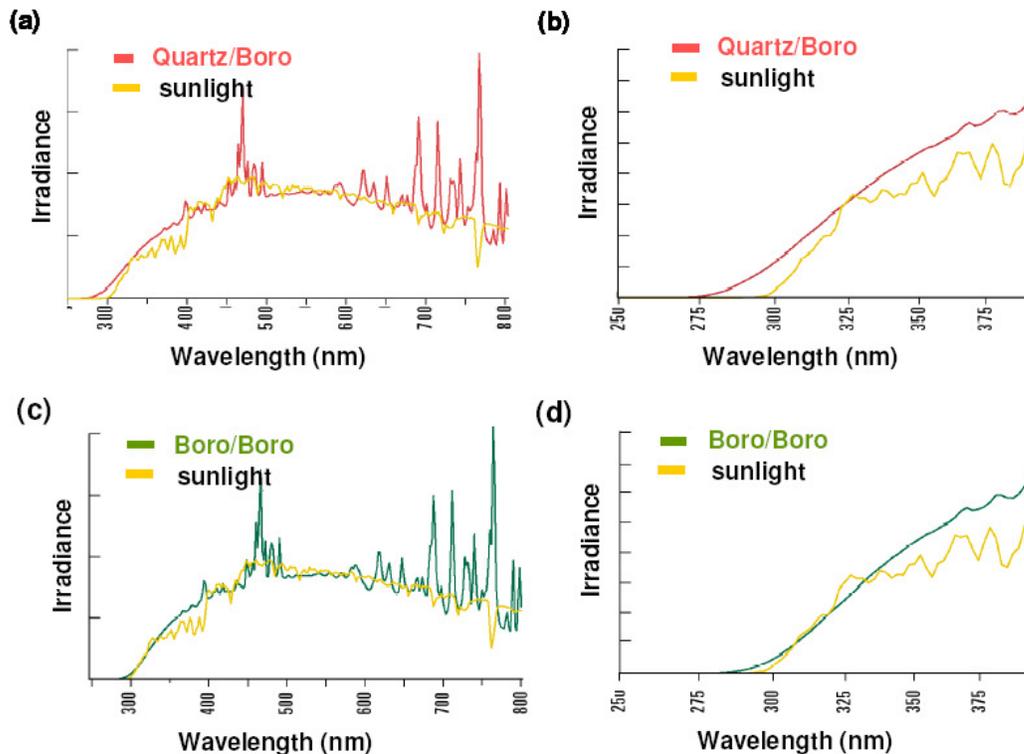
**Figure 3:** Comparison of sunlight vs. Boro/Boro & Quartz/Boro UV filtration<sup>4</sup>.

Historically, major automotive OEMs have specified SAE J1960 as a standard accelerated Xenon test method.<sup>5</sup> The parameters of this method are listed in Figure 2. The SAE J1960 method utilizes quartz inner and borosilicate outer filter combination that generates a spectral distribution containing unrealistic short wavelength radiation (which does not occur in the natural sunlight on earth). Due to the high energy of lower wavelength radiation, artificial damaging effects in organic materials can occur, resulting in misleading material performance. As a result, the automotive industry has accepted the use of borosilicate inner and outer filter combination as it provides a better match to natural sunlight, limiting the lower wavelength light emission. A comparison of the spectral distribution versus sunlight for the two filter combinations is shown in Figure 3. Some U.S. OEM's have adapted further modified methods based on the ASTM G155, which is favored by many European automotive manufacturers. ASTM G155 differs from the SAEJ1960 in that it does not have a dark cycle to mimic nighttime wetting, utilizes borosilicate inner and outer filters, and utilizes higher irradiance to increase the acceleration factor. In this study, sample exposure was carried out under the ASTM G155 method and performance readings on samples were taken every 900-1000 kJ/cm<sup>2</sup> at 340nm of exposure.

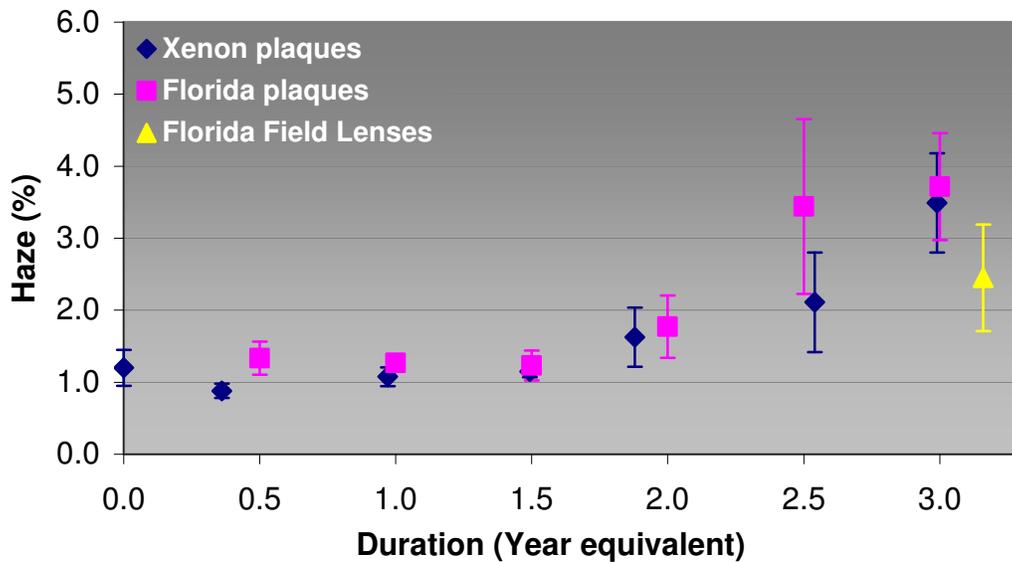
**Figure 4.** Haze performance in Xenon accelerated weathering plaques, Florida exposure plaques (45 degrees) and Florida “field” lenses. Data represents average of at least three sample measurements.

Injection molded LS2 clear polycarbonate test plaques coated with Momentive's weatherable UV-curable coating were weathered via accelerated Xenon G155 (modified) as well as natural Florida exposure. All Florida exposures were completed at Atlas Material Testing at a controlled test field in Miami, FL. Haze, transmission and yellowness index as a function of exposure time are reported in Figure 4 and 5. Data points represent the average of 3 replicate samples.

In headlamp applications, haze is a critical performance metric as it is the first mode of visible degradation in weathering. As shown in Figure 4, the coated plaques easily met the requirement mandated from the automotive industry for forward lighting (FMVSS108) – less than 7% haze on reflex reflectors. This performance metric is achieved in both accelerated Xenon testing as well as in natural Florida exposure. Note, in order to correlate the accelerated Xenon testing to Florida exposure, kJ of exposure at 340nm in a Xenon Weatherometer™ were converted to “years equivalent in Florida” using a correlation factor.<sup>3</sup> Because the total UV exposure varies in Florida from year to year, this is an approximation. Nonetheless, the data show that accelerated Xenon testing is a conservative predictor of performance with regard to haze. Both data sets overlap nicely, showing good correlation between these two test methods.

A further verification of the correlation was obtained from field lenses collected from Florida registered vehicles. Only one data point for these lenses could be obtained, as vehicles could not be tracked throughout their service lifetime. Lenses collected from the field at just over three years service were evaluated. These lenses show approximately 1% less haze than the control plaques exposed in Florida, showing excellent passing performance at three years with regard to haze, transmission as well as YI. The slightly improved performance in field lenses can be expected due to the inherent variability of a vehicle's exposure. The positive results are critical, as weatherability is not an inherent material property, but rather a system property. Therefore, the system as a whole is affected not only by the chemical composition of the protective coating, but also by the processing of the coating, by the stress state of the substrate to which the coating is applied, as well as by the final application/use of the coated part. To avoid product failure, the coating system must encompass a degree of robustness such that variations in these system parameters do not disrupt the overall performance. Correlating data from accelerated Xenon and controlled Florida exposure to field lenses helps confirm the robustness of the system design.

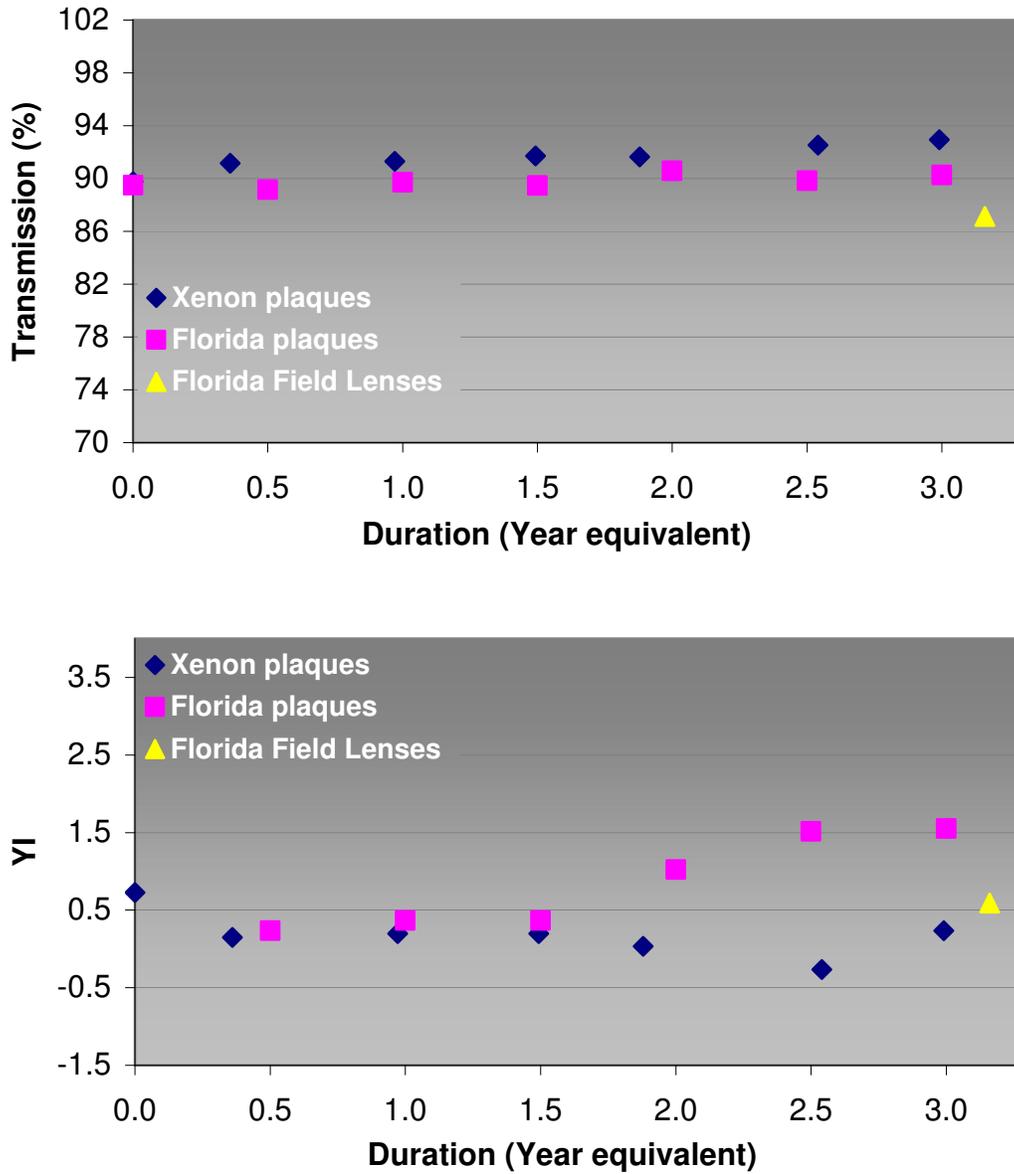
**Figure 5:** Comparison of transmission and YI in Xenon accelerated weathering plaques, Florida exposure plaques (45 degrees) and Florida “field” lenses. Data represents average of at least three sample measurements.

Similar to haze, measured transmission and YI of the weathered samples showed excellent correlation between accelerated and natural weathering (Figure 5). The data again show that accelerated weathering is a good and conservative predictor of real life (field) performance with this coating system.

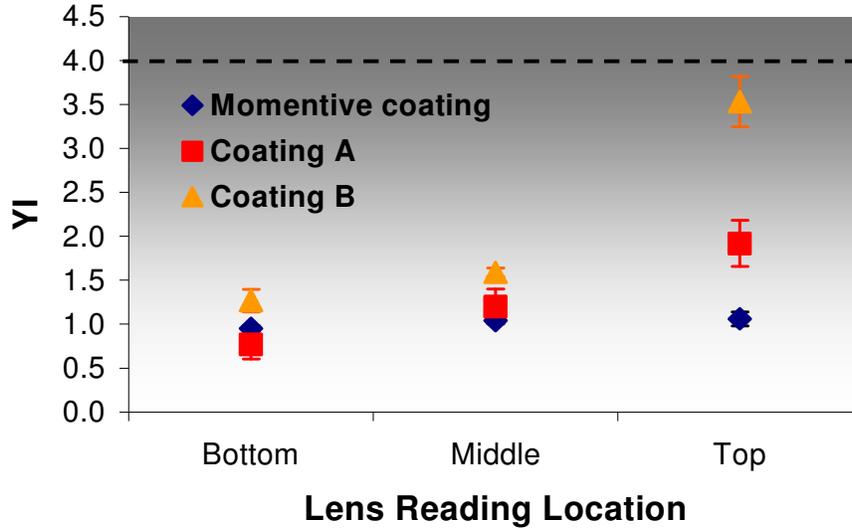
**Figure 8:** YI comparison of three coating systems with ca. 3 years in Florida. Readings were taken at top, middle, and bottom locations in front of headlamp beam. Dashed line designates limit for YI with regard to failure.

A more thorough study of field lenses has been completed to evaluate lens performance from top to bottom for both Momentive and other unknown competitive coatings. Figures 6, 7, and 8 show performance of multiple lenses with averaged performance for Haze, YI, and Transmission. The measurements for the lenses were taken from the top one-inch border of the lens, the middle (directly in front of the headlamp beam), and the bottom one inch. It was noted that coating degradation, when present, consistently started at the top of the lenses where the coating was approaching a horizontal orientation to sunlight. Similarly, performance loss with respect to haze and other properties tended to develop toward the top of the lens, and in severe cases, to proliferate down to the center, as with coating system A. Although AMECA and other

The Momentive coating achieved passing performance with regard to haze, yellowness and transmission at all lens locations, demonstrating robust performance even at the top of the lenses. Failure of competitive coatings is difficult to attribute to a specific mechanism. Because weatherability is a system property, encompassing coating chemistry as well as the coating application process, substrate variability, etc., a design weakness may exacerbate the impact of any one of these elements and lead to premature coating failure.

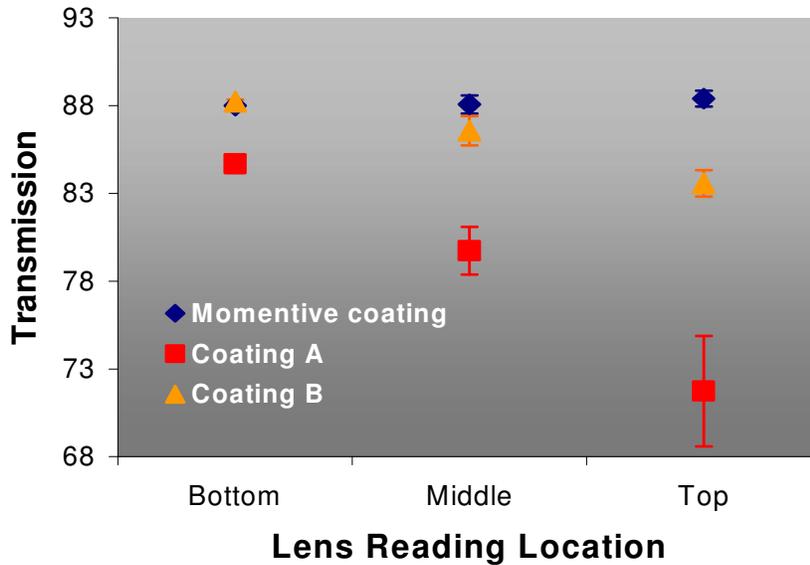
**Figure 7:** Transmission (%) comparison of three coating systems with ca. 3 years in Florida. Readings were taken at top, middle, and bottom locations in front of headlamp beam.
